Meigs Mine Pool Complex

Hydrologic affects and
early flooding conditions

December 6, 2007

ARC

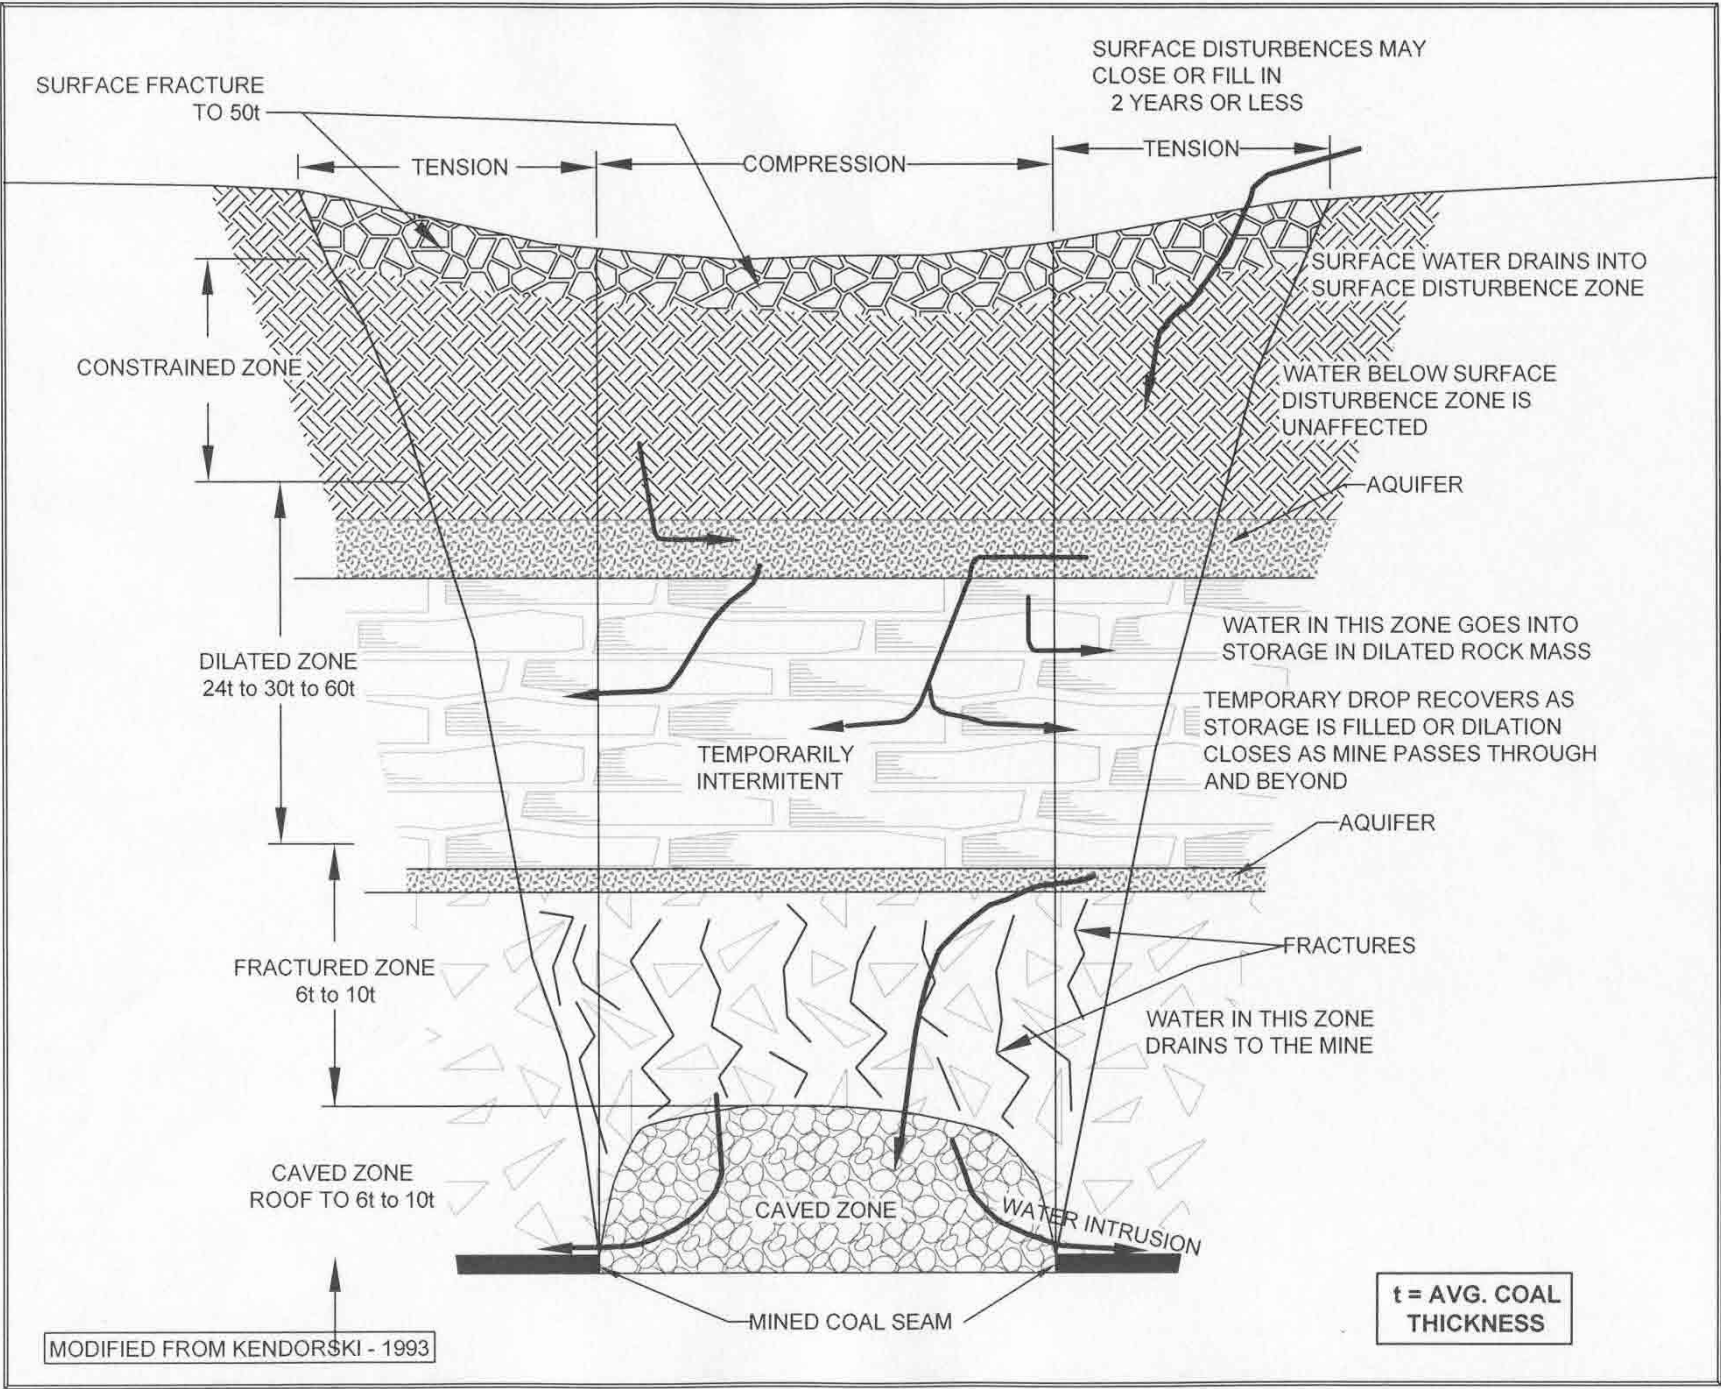
Hydrology affects from subsidence at the Meigs Mine

- Near surface water table lowered.
- Wells and springs dewatered.
- Increased secondary permeability and porosity.*
- Stream beds fractured, with water loss.
- In areas of low cover, water enters directly into mine.
- Otherwise, water disappears but emerges at lower elevation.
- Creation of mine pool

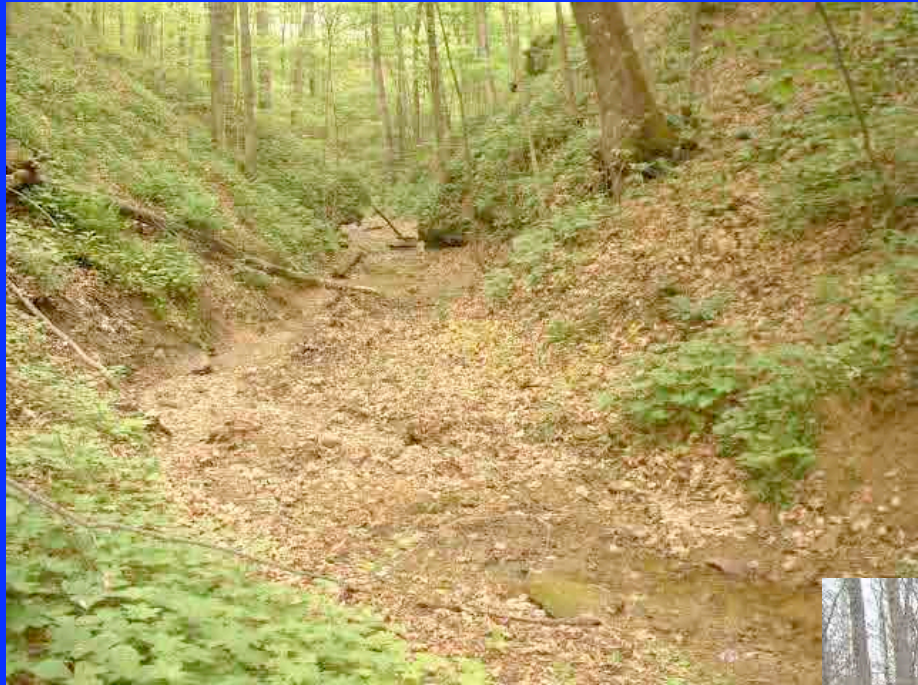
Trib to Sisson Run, 200 feet
to coal. Mined in 2002

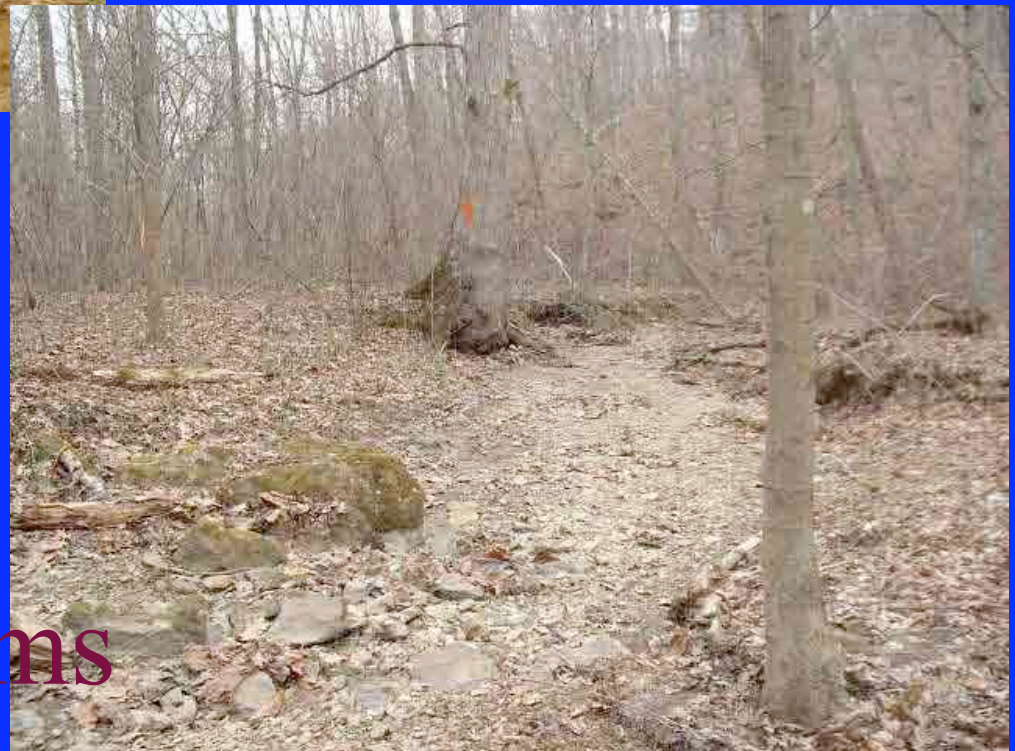
Dewatered Streams

Trib to Zinns Run. ~100
feet to coal. Mined in
1999.
